## **MINE SITE VISIT REPORT**

### **New Mexico AML Program**

**Date of Visit :** August 30, 2007      **Weather :** Sunny 85°  
**Mine/Project Name:** Barbara J # 1 Mine – Northwest of Grants, New Mexico  
**Duration of Visit :** 1.0 hour (10:00 am to 11:00 am)  
**Purpose of Visit :** Maintenance inspection to the Barbara J # 1 mine, part of the legacy site assessment for AML project sites.  
**Observations :** Travel to the project site; access to this site was from the west using a two track road. Location: SW1/4, NW1/4, NE1/4 of Sec. 20 T.13N., R.9W., Dos Lomas Quad. UTM Zone 13, E243060 N3913260, Uranium Mine. This site is on BLM land.

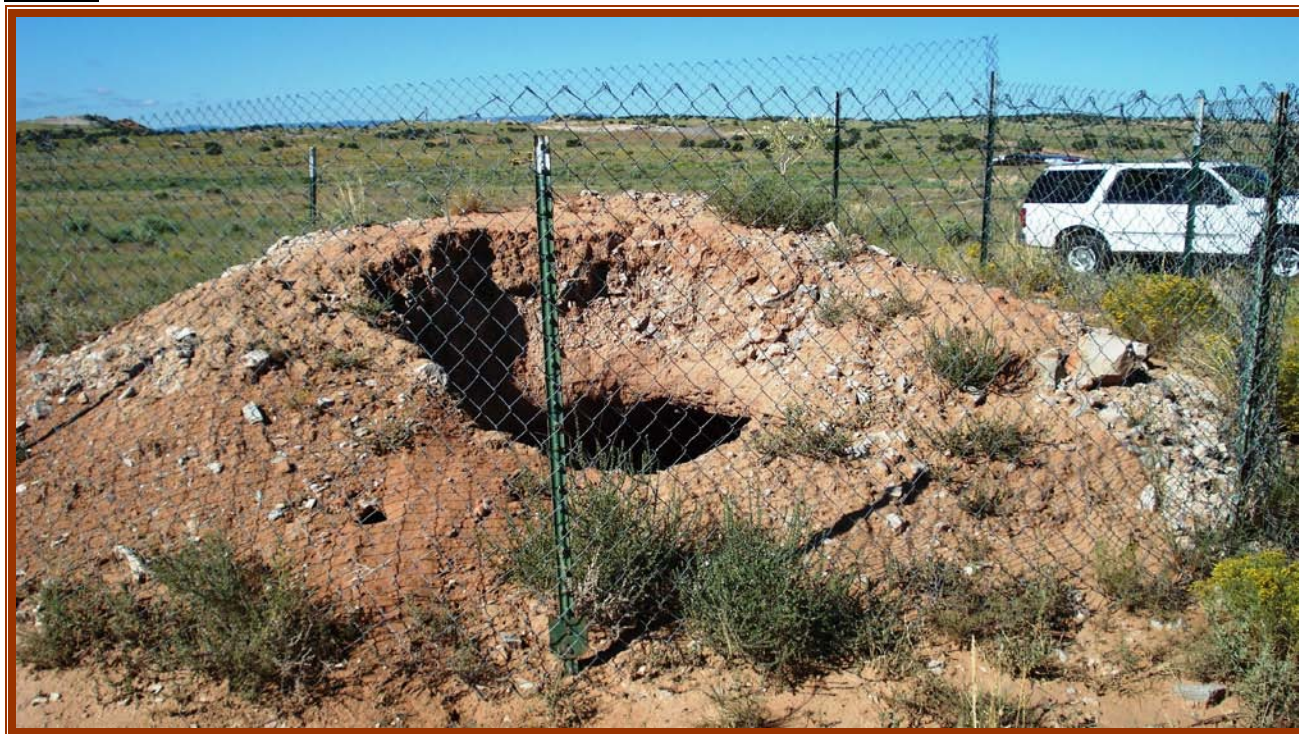
Signs of human activity were not recent. Vegetation is similar to undisturbed areas except for waste piles which lacked vegetation. Land use appears to be limited grazing for cattle but not recently. Previous reclamation is obvious. The shaft is fenced and subsided. Total site area is approximately 6 acres. The nearest residence appears to be over 1-mile away in the southern direction.

**Mine Shaft Subsided Looking Southwest**

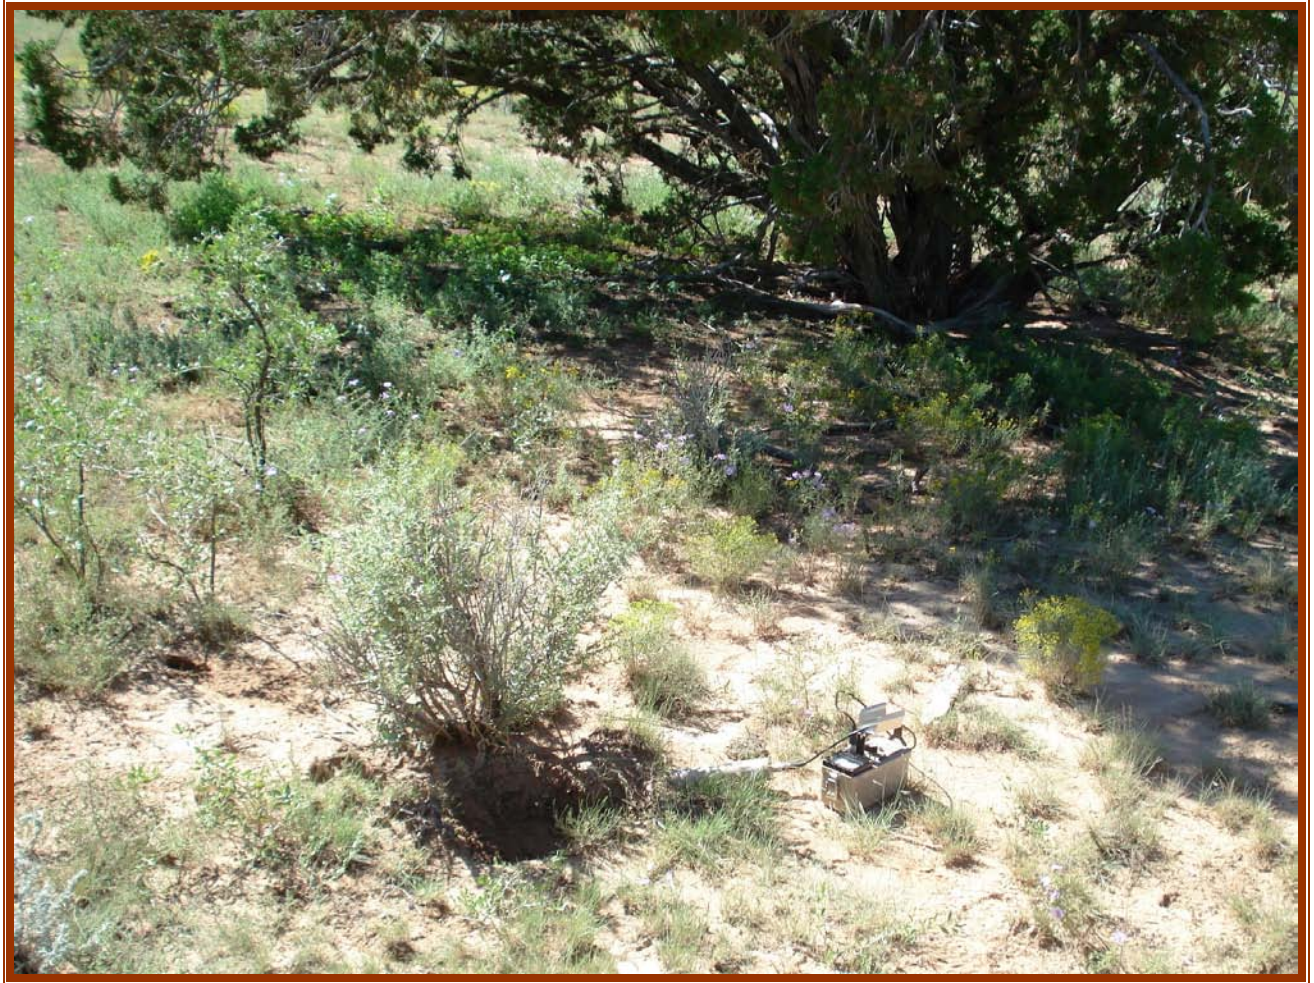
Background radiometric levels of 29  $\mu\text{R/hr}$  at both 1-meter and ground level, were read utilizing a Ludlum Model-14C survey meter with a NaI Model 44-2 Gamma Scintillator probe and were taken at the drill hole pictured below. The overall waste and ground within the middle portion of the disturbance area have radiometric levels of 114-257  $\mu\text{R/hr}$  at 1-meter and 200-429  $\mu\text{R/hr}$  at ground level.

**Mine Drill Hole Looking East**

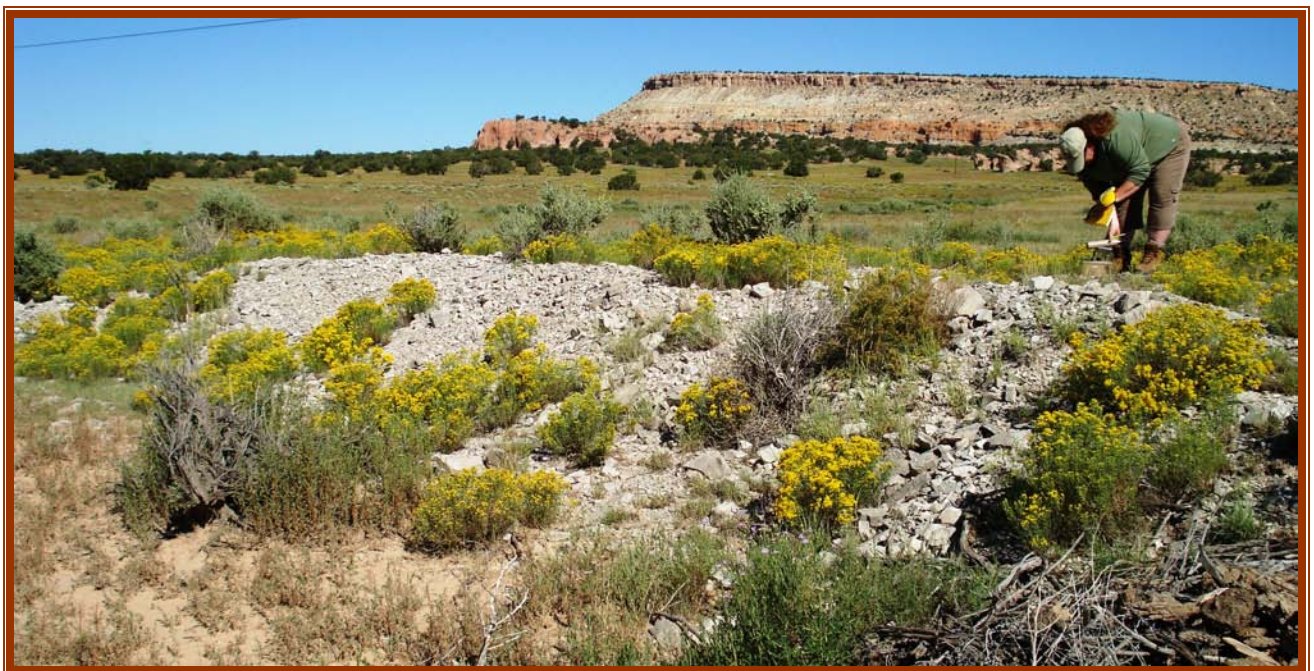
This site has areas of mounded waste, concrete foundations, some wood and metal mining debris. There is a drainage along the north edge of the site heading east towards a larger arroyo. For complete details see topographic GPS info using the MapGuide map found at [http://164.64.103.6/mmdtest/AML\\_Uranium-DEV.htm](http://164.64.103.6/mmdtest/AML_Uranium-DEV.htm)

## Mine Waste Pile Looking Northwest

Further action recommended to mitigate radiometric levels. No other safety concerns at this time.
